USACERL Interim Report FM-94/08  
April 1994

## Field Test Results of Corrosion-Resistant Coatings for Carbon-Steel Steam Condensate Return Lines

by  
Vincent F. Hock  
Henry Cardenas  
James R. Myers

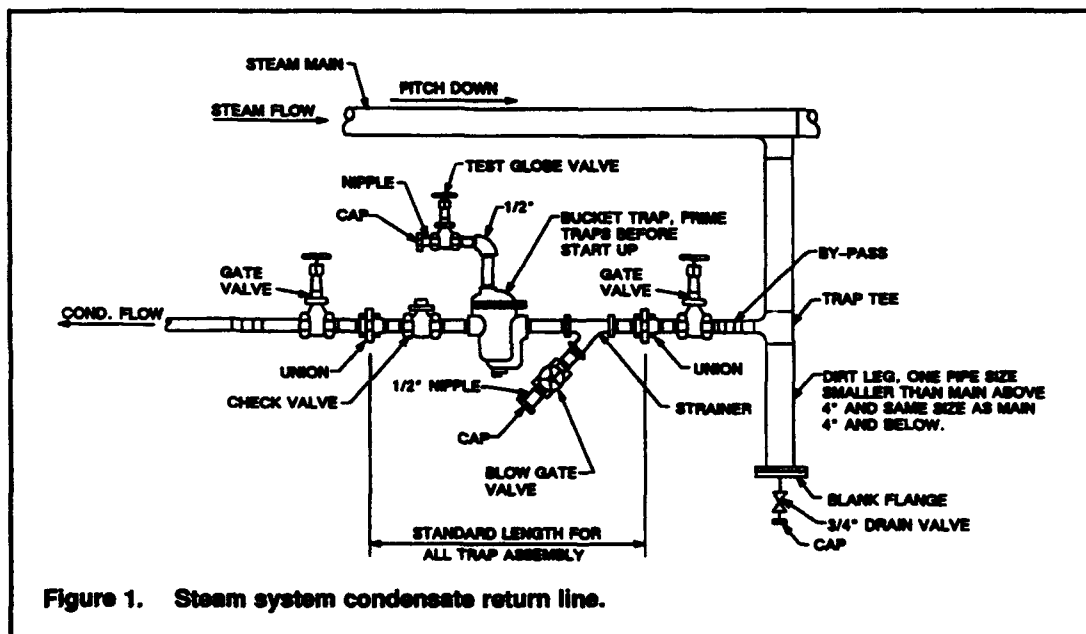
Condensate return lines can also be found in association with steam traps, the basic function of which is to separate mixtures of steam and condensate so that steam is fed back to the steam flow while water is released to the condensate return lines (Figure 1).

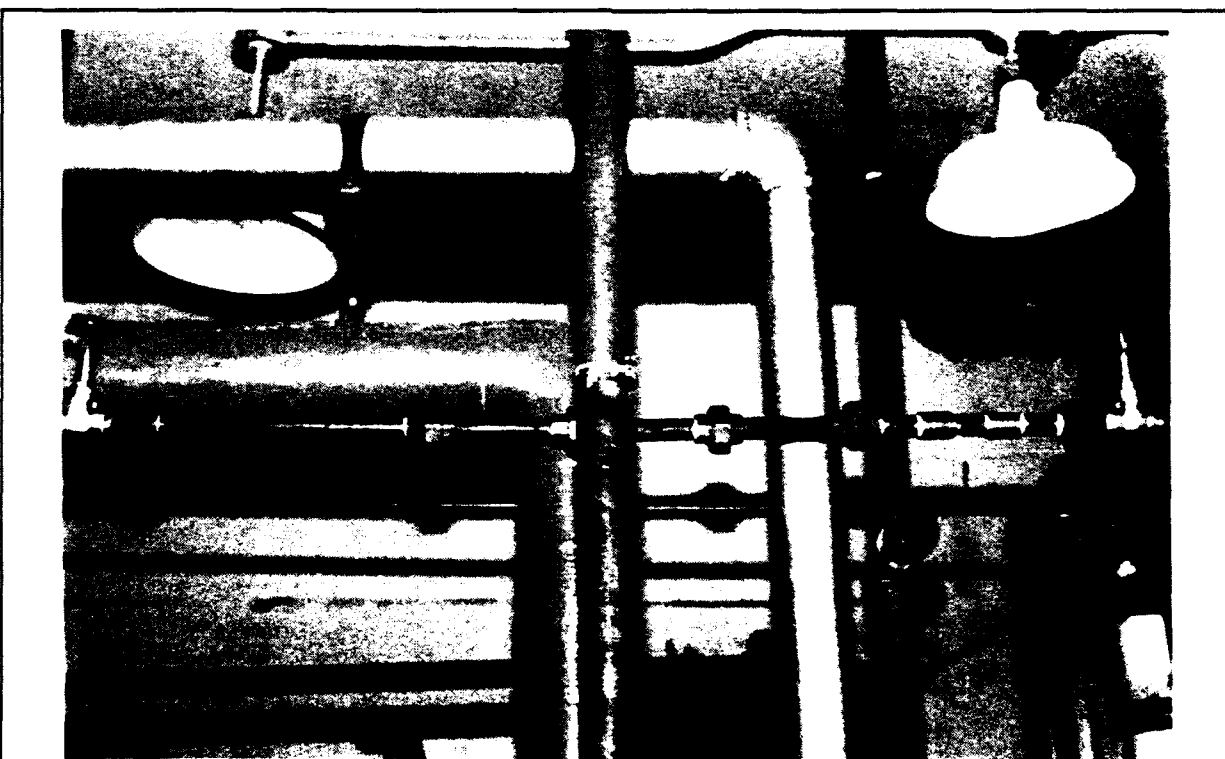
Five in-line test pipes were installed at each building. Figures 6, 7, and 8 show the test pipe installations at buildings 2490, 2482, and 9827 respectively. Test pipe A was removed and analyzed from each site after 90 days.

Figure 7. In-line condensate test pipes, Bldg 2482, Fort Meade, MD.
